Manhole Inspection Summary

Manhole # S19A1_017MH

Location Address: **2527 washington bd**

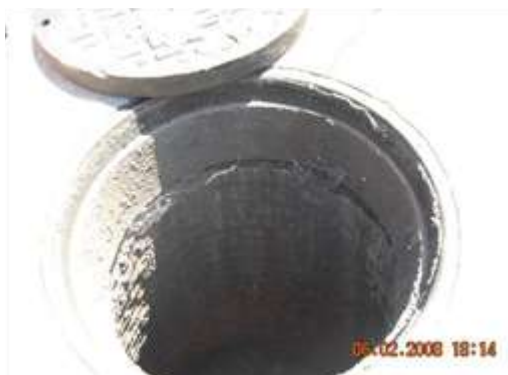
Defect 1

☒ **Leaks**

Condition: ☐ Sound ☐ Cracked ☐ Root Intrusion ☒ **Loose Brick** ☐ Deteriorated

chimney loose bricks, frame leaks-inflow
evidence from sheeting

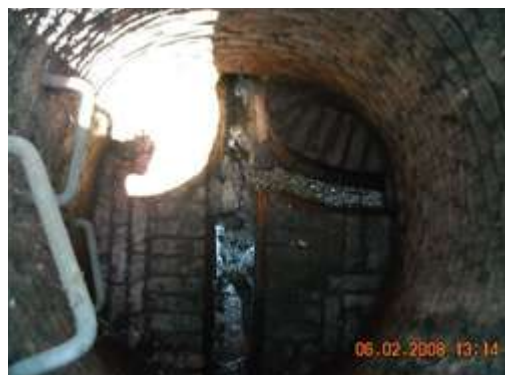
Defect 2

Condition: ☐ Sound ☐ Cracked ☐ Root Intrusion ☐ Deteriorated ☐ Leaks ☒ **Debris**

frame leaks;channel debris

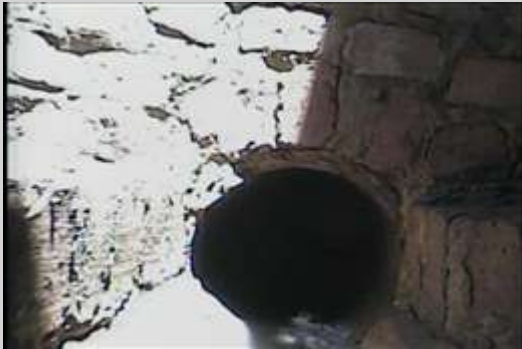
12 O'Clock Outflow

8 in. Circular Gravity Sewer
Pipe Out @ 12 O'Clock

Pipe Height: **8.4** (in.) Rod and Bar (Angled)
Pipe Material: **Clay** ☐ Pipe Lined
Invert Depth: **7.40** (ft.) Flow Characteristics: **Slow**
Deposits: ☒ None ☐ **Mud** ☐ Sludge ☐ Debris ☐ Grease
Silt Depth: **0** (in.) Deposits Extent:
Infiltration: **None** Pipe Seal Cond: **Cracked**

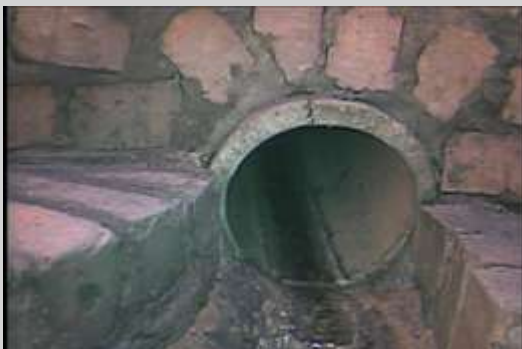
3 O'Clock Inflow

6 in. Circular Gravity Sewer
Pipe In @ 3 O'Clock

Pipe Height: **6** (in.) Rod and Bar (Angled)
Pipe Material: **Clay** ☐ Pipe Lined
Invert Depth: **6.75** (ft.) Flow Characteristics: **Slow**
Deposits: ☒ None ☐ **Mud** ☐ Sludge ☐ Debris ☐ Grease
Silt Depth: **0** (in.) Deposits Extent:
Infiltration: **None** Pipe Seal Cond: **Cracked**

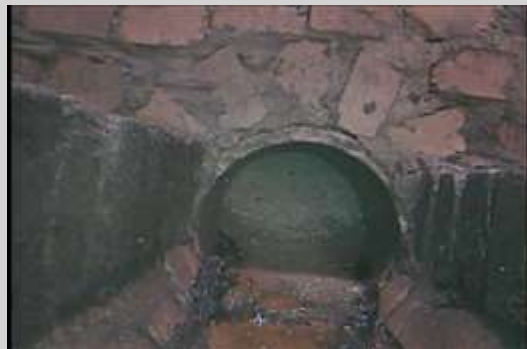
6 O'Clock Inflow

8 in. Circular Gravity Sewer
Pipe In @ 6 O'Clock

Deposits: ☐ None ☒ **Mud** ☐ Sludge ☐ Debris ☐ Grease

Silt Depth: **2** (in.) Deposits Extent: **Light**
